Intake Structure Rehabilitation and Strengthening

Crystal River, FL

Submitted by MAPEI Corporation

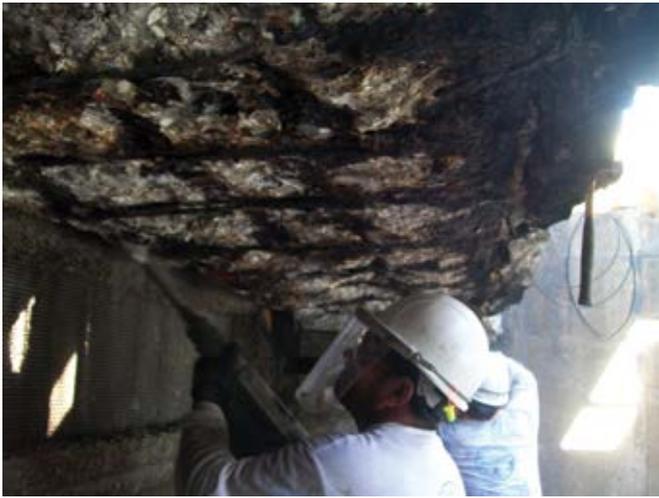
Workers chipping deteriorated concrete. Note complete loss of reinforcing steel

Most of the steel reinforcement that was exposed and any reinforcement with minimal concrete cover was corroded to the point of nonexistence. The majority of the steel reinforcement had to be replaced with new reinforcing bars that were doweled and bonded with epoxy into the existing slabs and support beams to accept the new concrete restoration materials.

All seven overhead beams in all four chambers had severe structural deficiencies, making it easier than normal to locate all hollow sounding areas that were marked for concrete removal. On all concrete repairs, saw cutting around the spalled areas was completed, creating right angles wherever possible. As per ICRI and American Concrete Institute (ACI) standards, the highly contaminated concrete was removed from behind the reinforcing steel to allow for placement of the repair material,

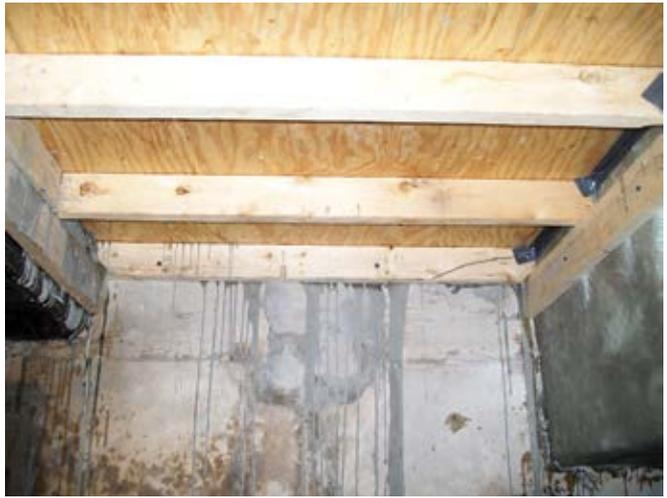
View of overhead deck repair with forms in place for pouring repair mortar

Because most of the repairs were overhead, a one-component, polymer-modified, corrosion-inhibiting, enhanced form-and-pour repair material was used. This material was pumped from the top side of the walkway through openings saw cut in the slab. Wooden forms were erected in an already-difficult work area where headroom was scarce.

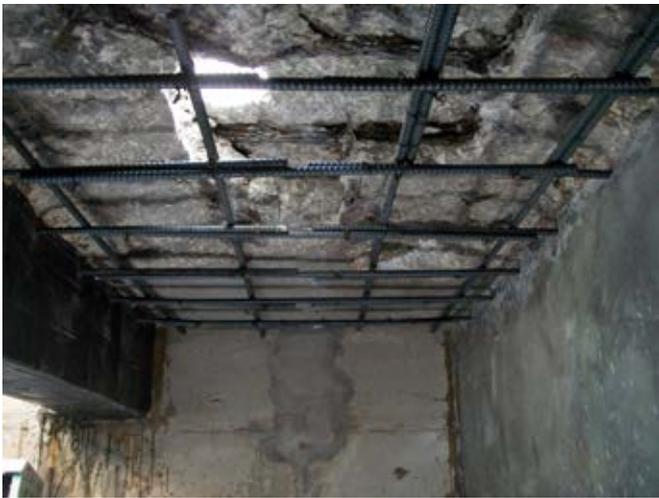
View of overhead deck area showing replaced reinforcing steel

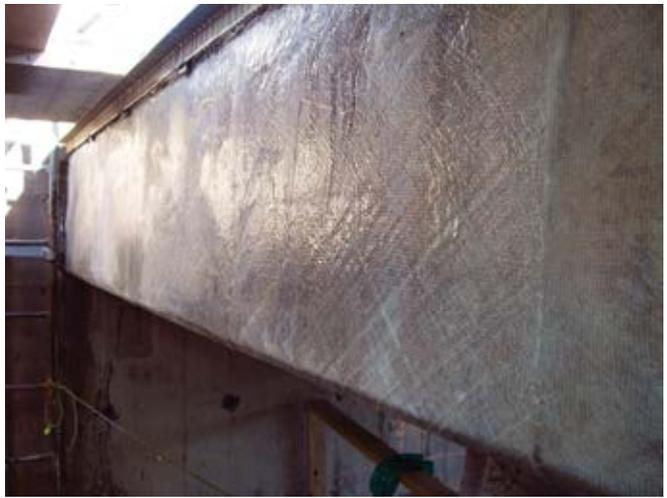
Fiber-reinforced polymers encasing existing beam

It was decided early in the planning stages that a carbon-fiber system would be added to the rehabilitation to provide additional support capability. Because of the severe loss of steel reinforcement and the cross section on the remaining steel, it was thought that a carbon-fiber system would not only add to the strength of the concrete where the reinforcement had been compromised but

would also provide a noncorrosive barrier to prevent additional chloride contamination to the repaired overhead concrete slab and beams.

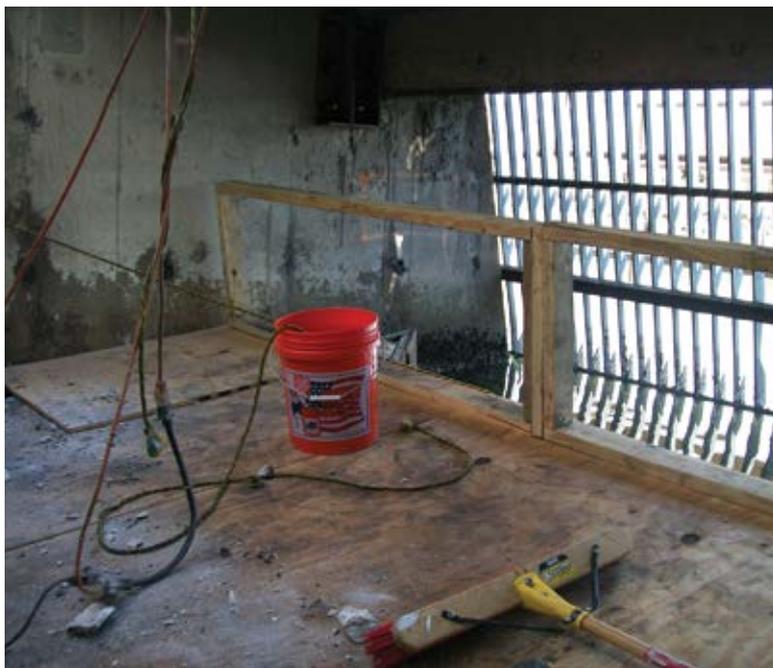
Floating platform fabricated to work inside intake chambers

The clearance problem was overcome by building floating platforms that were lowered piece by piece into the chambers, where they were assembled and covered over with marine plywood. These floating platforms were built “wall to wall” with a gap of approximately 3 in. (76 mm) all around the perimeter and with handrails constructed at both ends. When one cell was completed, the platform was simply dismantled and brought to the next chamber, where it was reassembled. At the end
