# Dock Rebuild and Strengthening

Tampa, FL

Submitted by Premier Corrosion Protection Services, Inc.

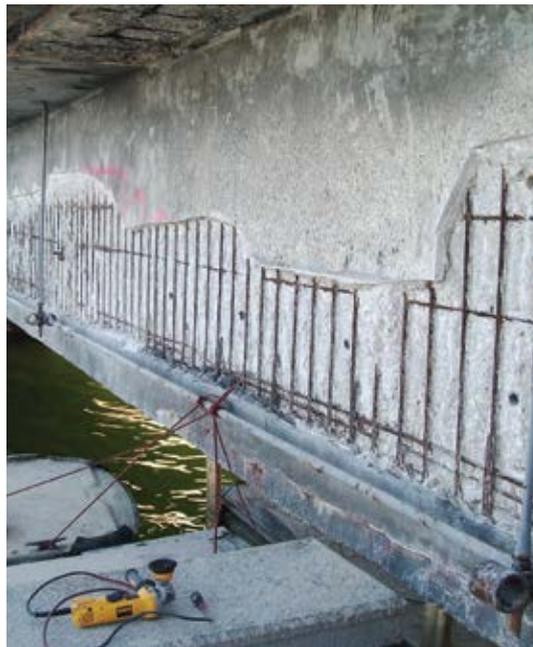
Concrete being prepared for repair on bottom of beams

Contaminated concrete was removed from behind the reinforcing steel and an epoxy bonding agent/corrosion inhibitor was applied. A high-strength, fast-curing, silica-fume-enhanced polymer concrete was then used to fill the prepared areas to be flush with the existing surfaces.

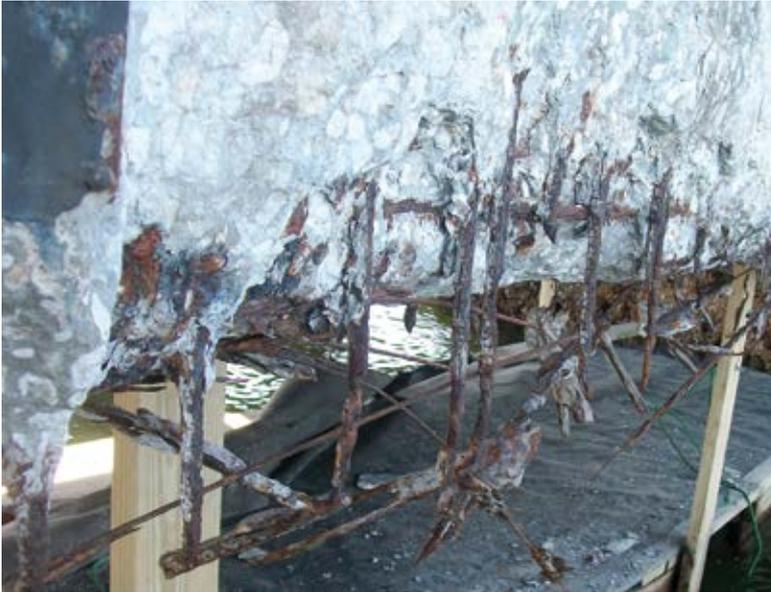
The remainder of the dock had numerous cracks and spalls on the beams caused by saltwater infiltration due to its close proximity to the water. The bottom of the beams were only 6 in. (152 mm) above the water at high tide and were frequently below water during mean high tide (at full moon) and when ships' wakes splashed them.

*Deteriorated concrete being removed from bottom of beams*

In addition to this repair, the bottom of all the beams were repaired over their entire length and encapsulated with fiber-reinforced polymer (FRP) composite material (fiberglass) for a minimum of 2 ft (0.6 m) above the bottom in stirrup fashion to ensure that there would not be any water infiltration to the beams.

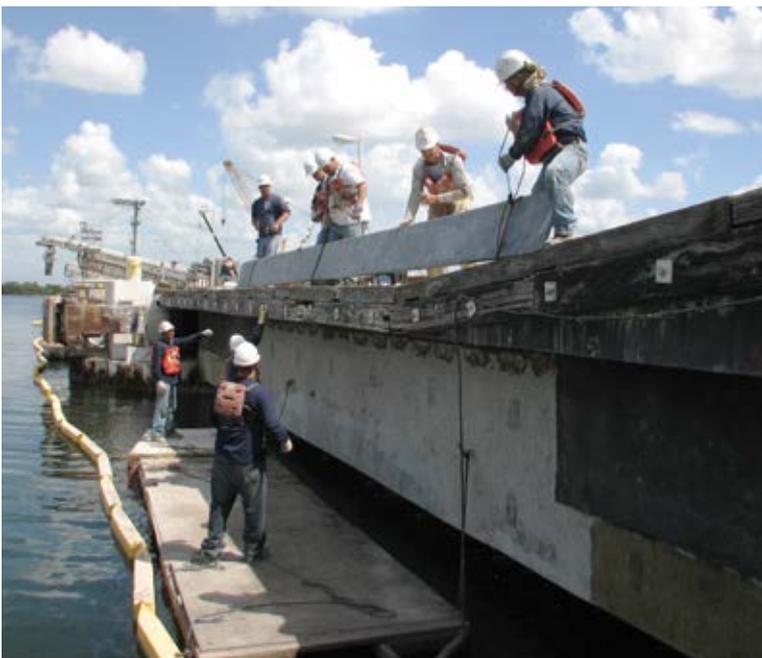
*Work was difficult, as it had to be performed from the water*

Prefabricated floating platforms were constructed and towed to site. These platforms were secured to one another, making a continuous floating platform, and were secured to the dock with expansion bolts and lines, allowing the platforms to rise and fall with the tides. A floating turbidity barrier was secured around the working area.

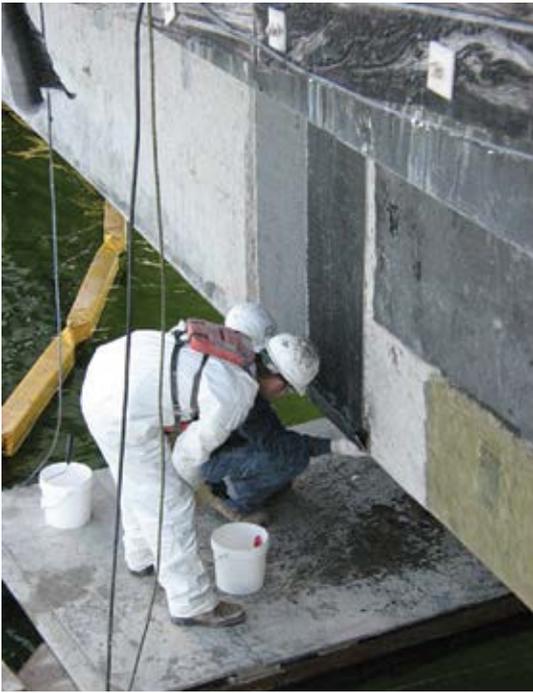
Installation of FRP wrap

Using a single-component, high-strength, silica-fume-enhanced concrete allowed FRP composite material to be installed on the entire length of the bottom of each beam. The FRP wrap was installed in stirrup fashion 2 ft (0.6 m) up each side and across the bottom, fully encapsulating the bottom of the beams, ensuring no further water intrusion and preventing any further spalling or cracking.

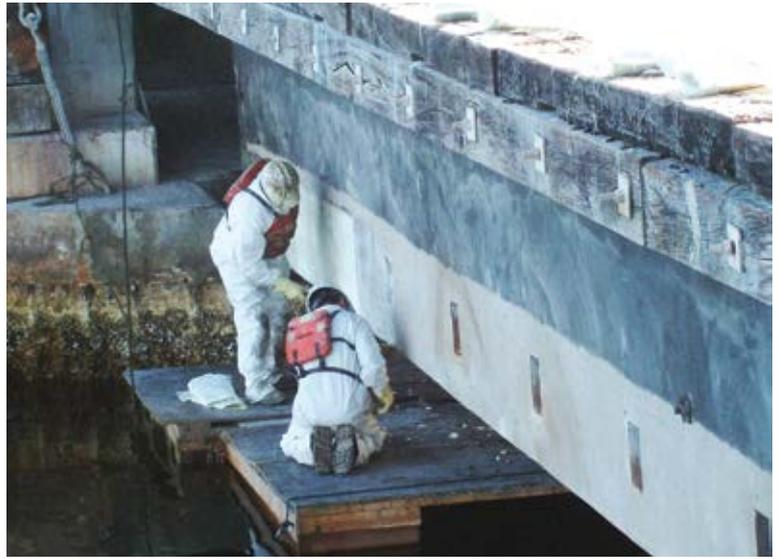
Workers completing repairs on bottom of beams

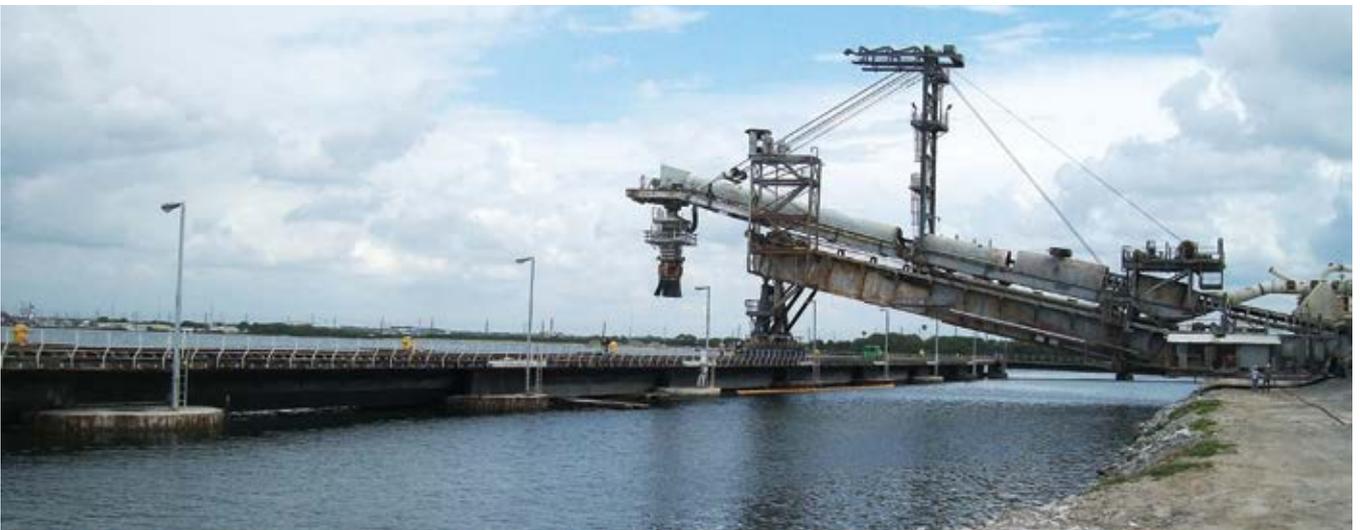
Completed repairs on dock showing loader
