WATER STRUCTURES CATEGORY

Historic Dam Structural Repairs

NORTH CAROLINA

SUBMITTED BY PREMIER CORROSION PROTECTION SERVICES, INC.

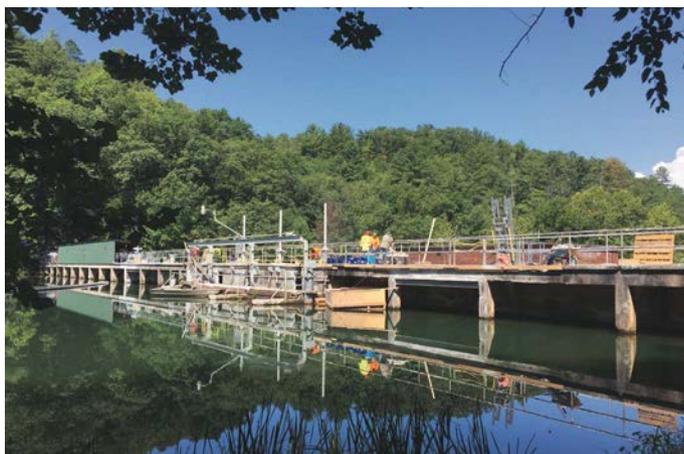
The project was to repair a 325 ft (99 m) long concrete walkway at a 95-year-old dam that had serious concrete spalling and numerous cracks throughout its entire surface. Upon mobilization and further inspection, it was found that many of the structural components were in need of immediate repair. These components consisted of both transverse and lateral beams, structural buttresses, as well as the underside of the walkway itself. The underside of the walkway had multiple

areas of overhead concrete spalling, failure of arch support, as well as failure at three concrete beams. One of the four main buttresses had significant cracking transversing the entire buttress.

ICRI Guidelines for concrete repair. Additional reinforcing for the beams was provided using carbon fiber, which was installed in stirrup fashion at all the beam-ends. The cracks in the buttresses were filled with epoxy. Carbon fiber “anchors” were dowelled and embedded with epoxy into the adjacent wall and splayed over the side of the buttress, giving the carbon fiber-reinforced polymer (CFRP) a “mechanical anchor.” CFRP was then installed over the anchors and wrapped over the four sides of the buttress. Upon completion, two coats of Class 5 coating were applied. New forms were installed along the sides of the walkway as well as the sides of the beams and archway. The archway was placed from the top with dowels extending into the slab.

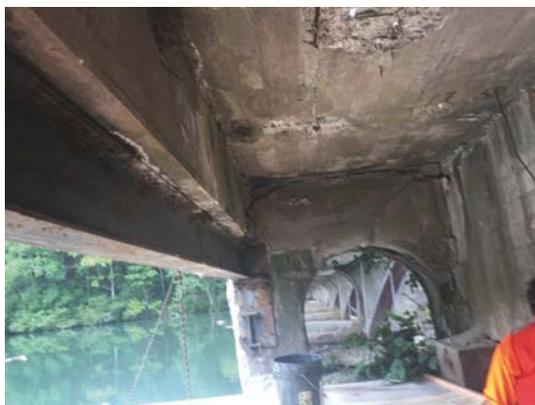
The physical aspects of this project were challenging due to confined spaces, the severity of the structural damage, and strict environmental regulations. The contractor completed surface preparation for the slab repair in accordance with
