Covanta Energy Cooling Tower Rehabilitation

Miami, FL

Submitted by MAPEI Corporation

2011 Award of Merit

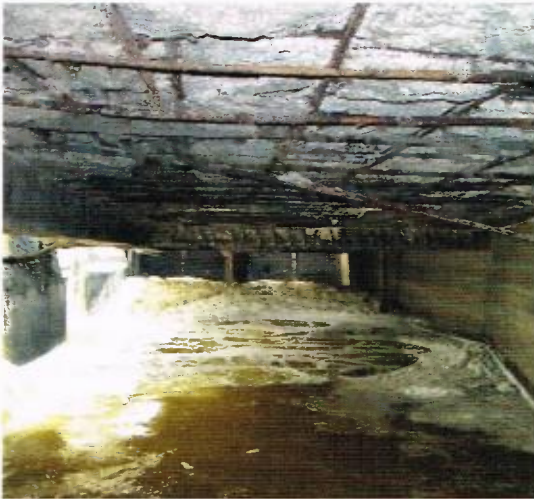
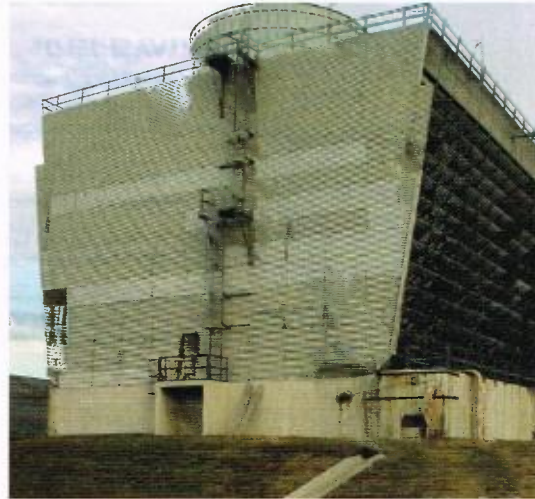
Built in 1976, this 255 x 68 in. (77.7 x 20.7 m) cooling tower is divided into six different chambers. The “overflow channel” is 8 ft (2.4 m) wide x 255 ft (77.7 m) long. This is where most of the concrete repairs took place. The scope of the work included designing the repair and strengthening system of the walkway. This area is similar to a bridge piling. With advanced corrosion and concrete deterioration, operation of the facility came dangerously close to forcing a shutdown.

Large volumes of overhead repair proved to be too costly to perform a trowel application of a repair mortar. The total length of each flume was approximately 40 ft (12.2 m) long and 8 ft (2.4 m) wide. There was only 4 ft (1.2 m) of clearance from the bottom of the slab to the top of the water. The clearance problem was overcome by fabricating a floating platform. The platform moved continuously as the water level rose and fell throughout the day. The platform had two floats approximately 2 ft (0.6 m) wide on each side, enabling the water to run between the “pontoons” and not impede the flow of the water in the flume area. After all of the concrete repairs to the underside were completed and properly cured, a layer of triaxial carbon fiber was installed over the entire underside of the slab.
